**Total Land Subsidence in the Butler Valley Area, La Paz County**  
**Based on Sentinel-1 Satellite Interferometric Synthetic Aperture Radar (InSAR) Data**  
**Time Period of Analysis: 5.0 Years 04/23/2017 To 05/15/2022**

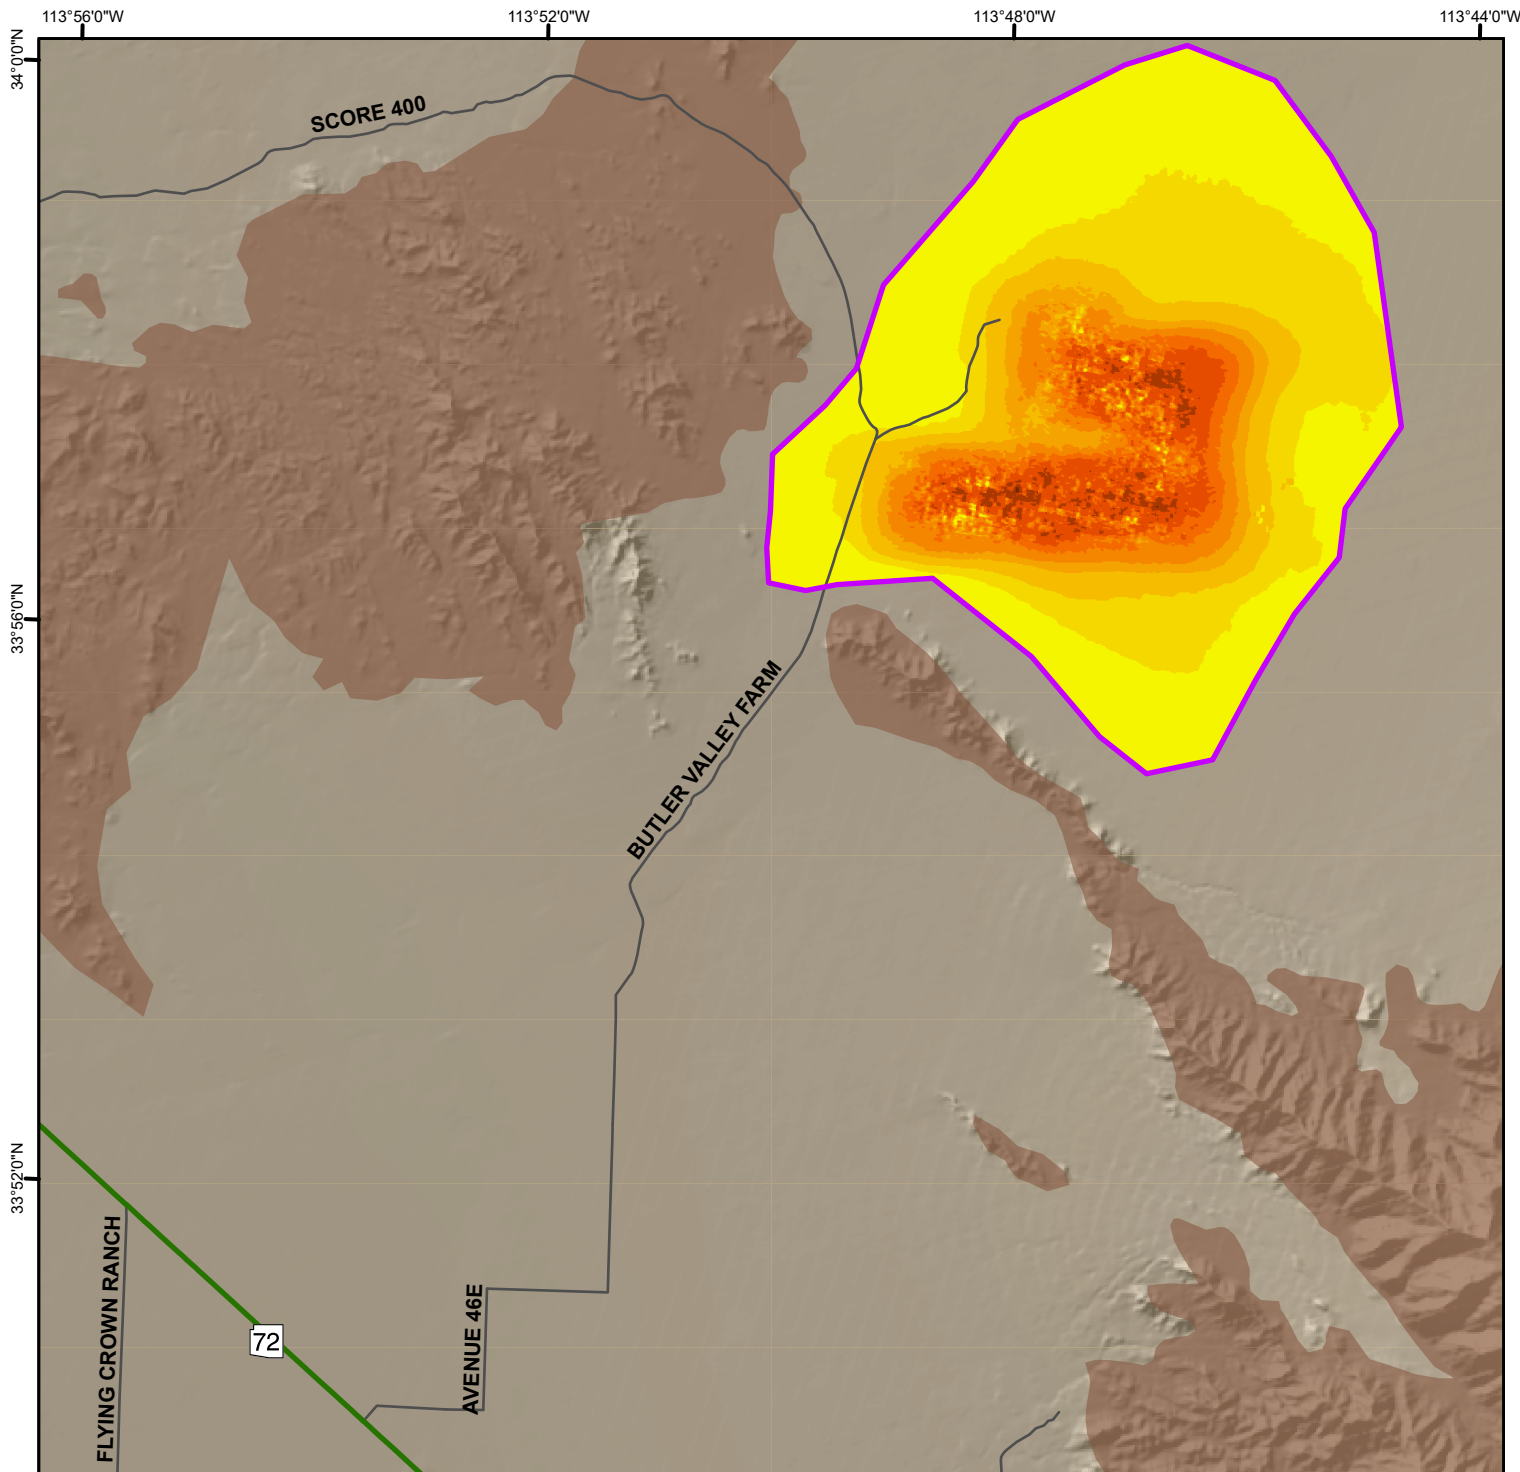
Decorrelation (white areas) are areas where the phase of the received satellite signal changed between satellite passes, causing the data to be unusable. This occurs in areas where the land surface has been disturbed (i.e. bodies of water, snow, agriculture areas, areas of development, etc).
